SOUTH ENTRANCE ROAD
(Grand Canyon Route #2)
Between south park boundary and Village Loop Road
Grand Canyon National Park
Coconino County
Arizona

HAER No. AZ-45

SOUTH ENTRANCE ROAD
(Grand Canyon Route #2)
HAER No. AZ-45

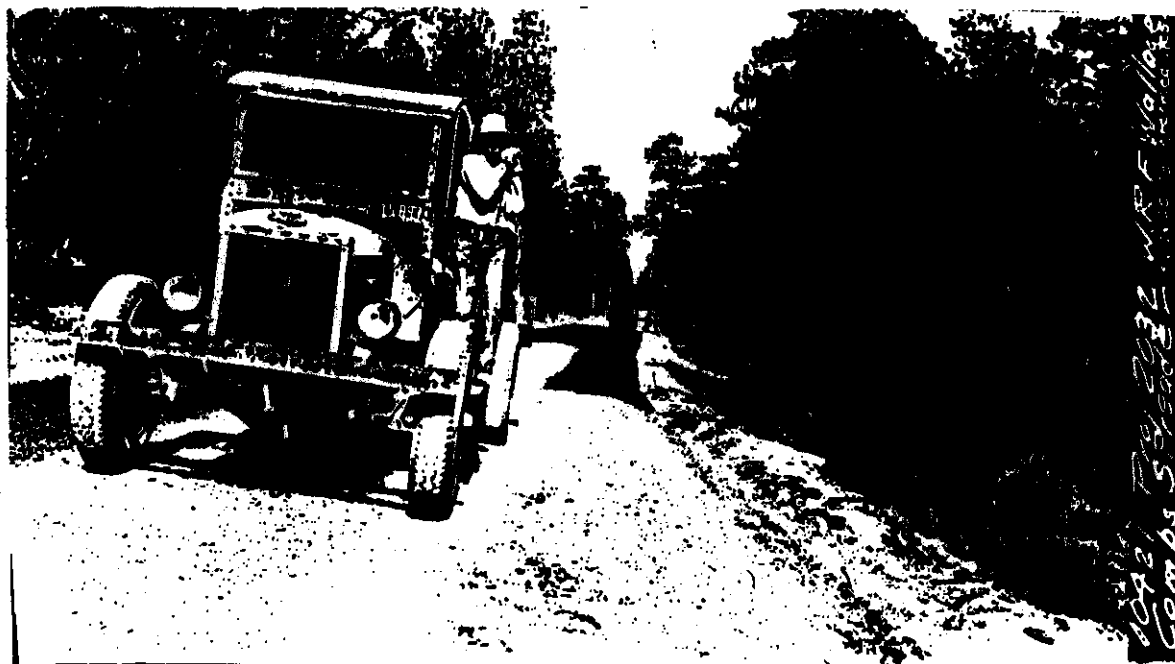
Figure 5. Vallandigham workers subgrading (above) and surfacing (below) during 1927-28 South Entrance Road Construction. (Final Construction Report, GCSC)

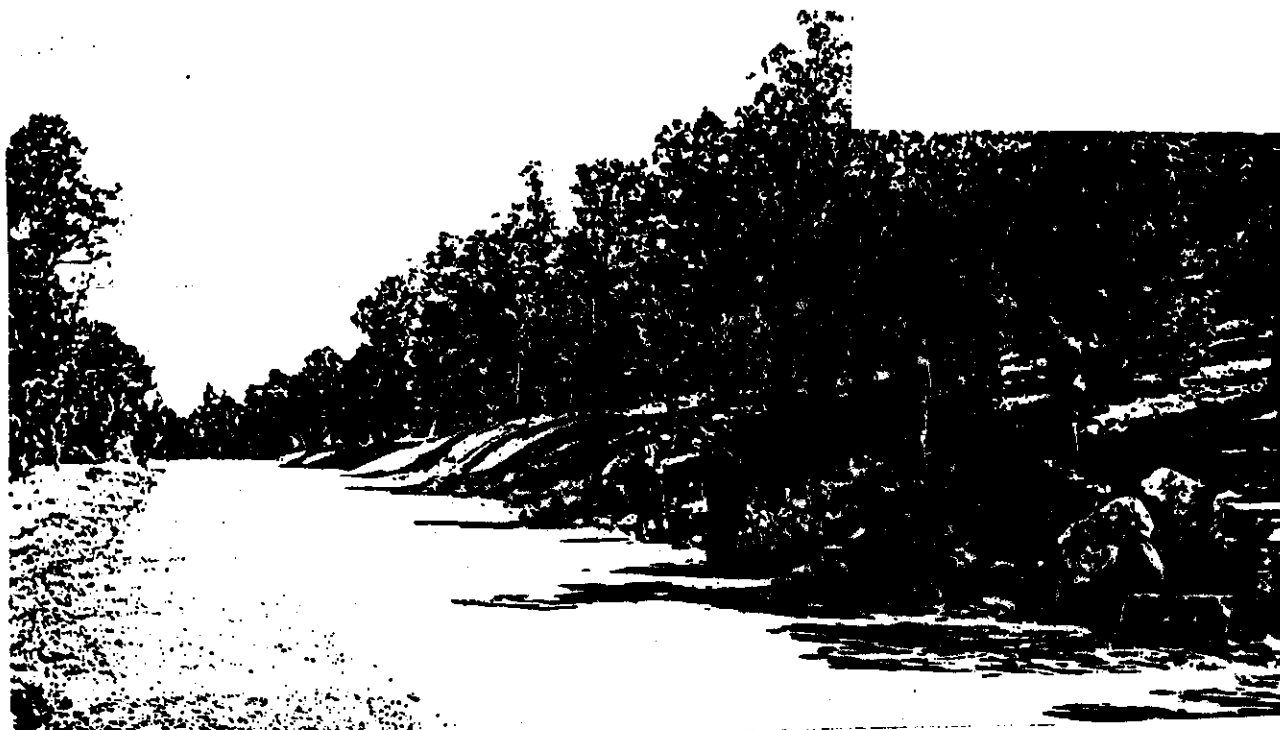
Figure 9. CCC crews rounding slopes along the South Entrance Road, 1937. (GRCA Image #285, GCSC)

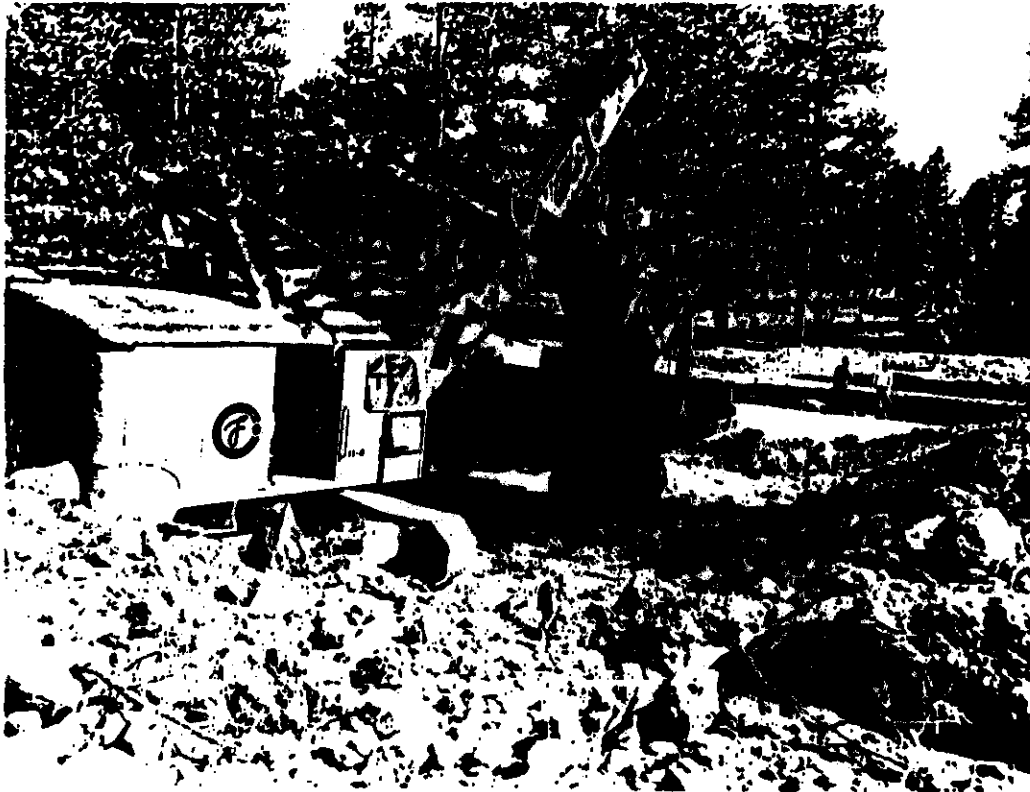
Figure 11. Fisher Contracting Company shovel and 12-yard dump truck working on the first segment of the new South Entrance Road near Yavapai Point, July 1953. (GRCA Image #2585, GCSC)

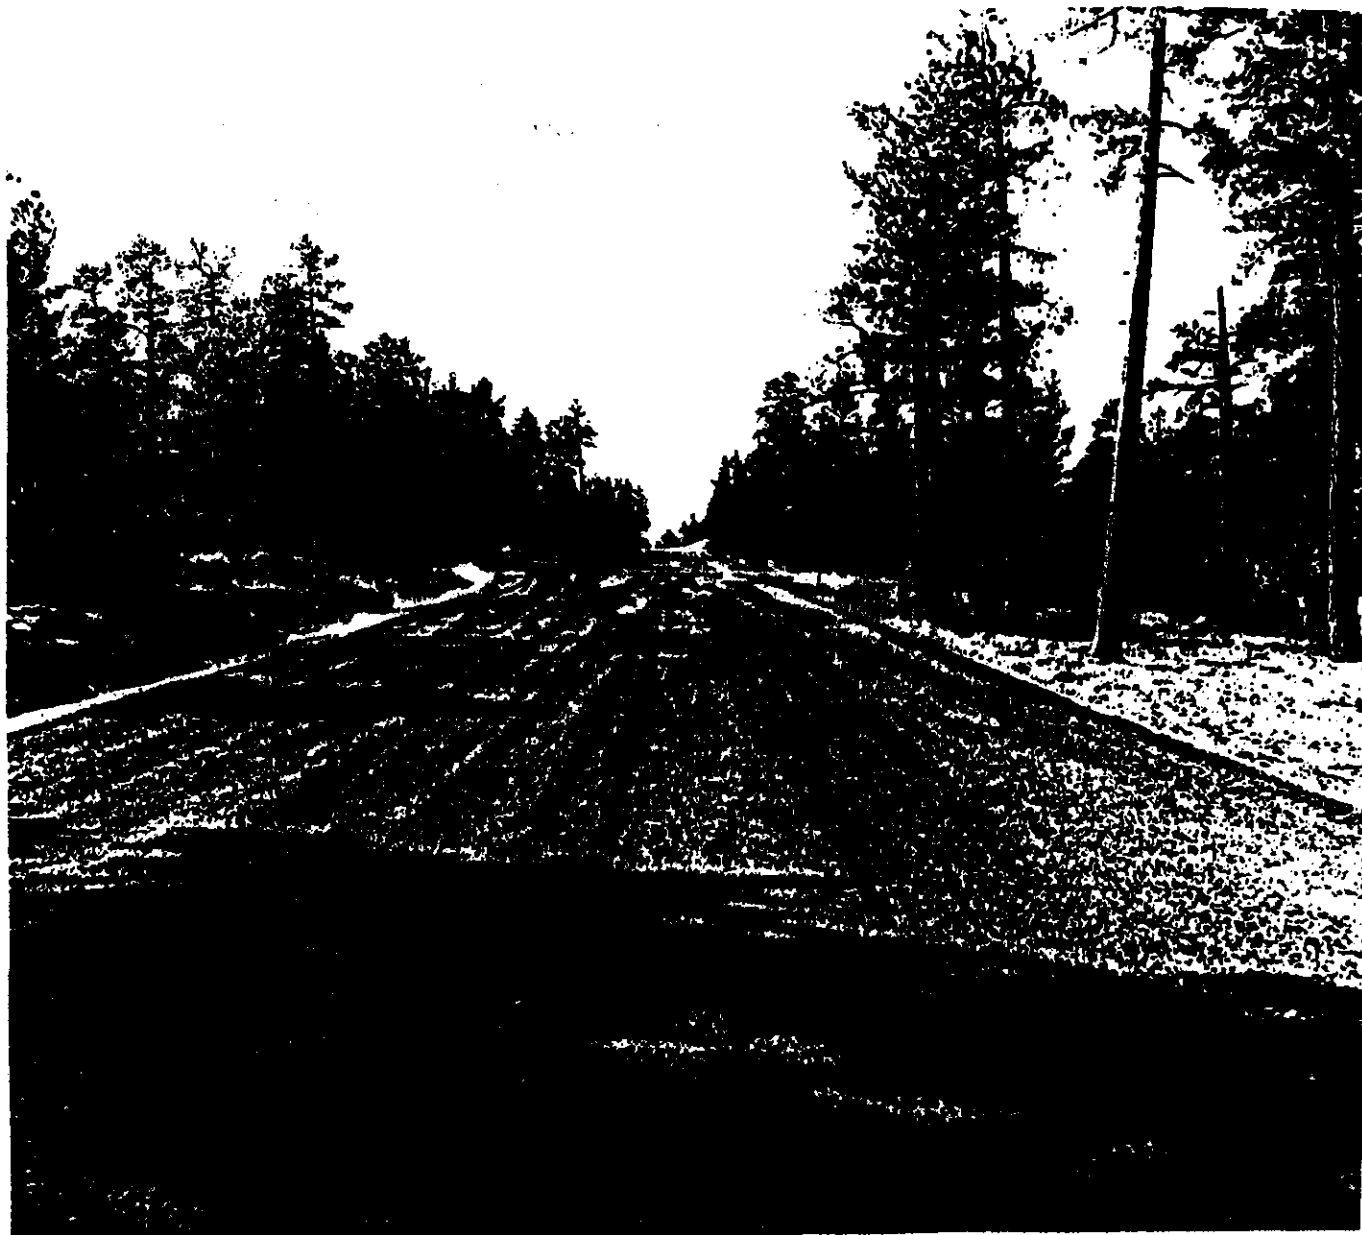
Figure 13. Segment of new South Entrance Road at site of new entrance station, September 1954. (GRCA Image #3190, GCSC)

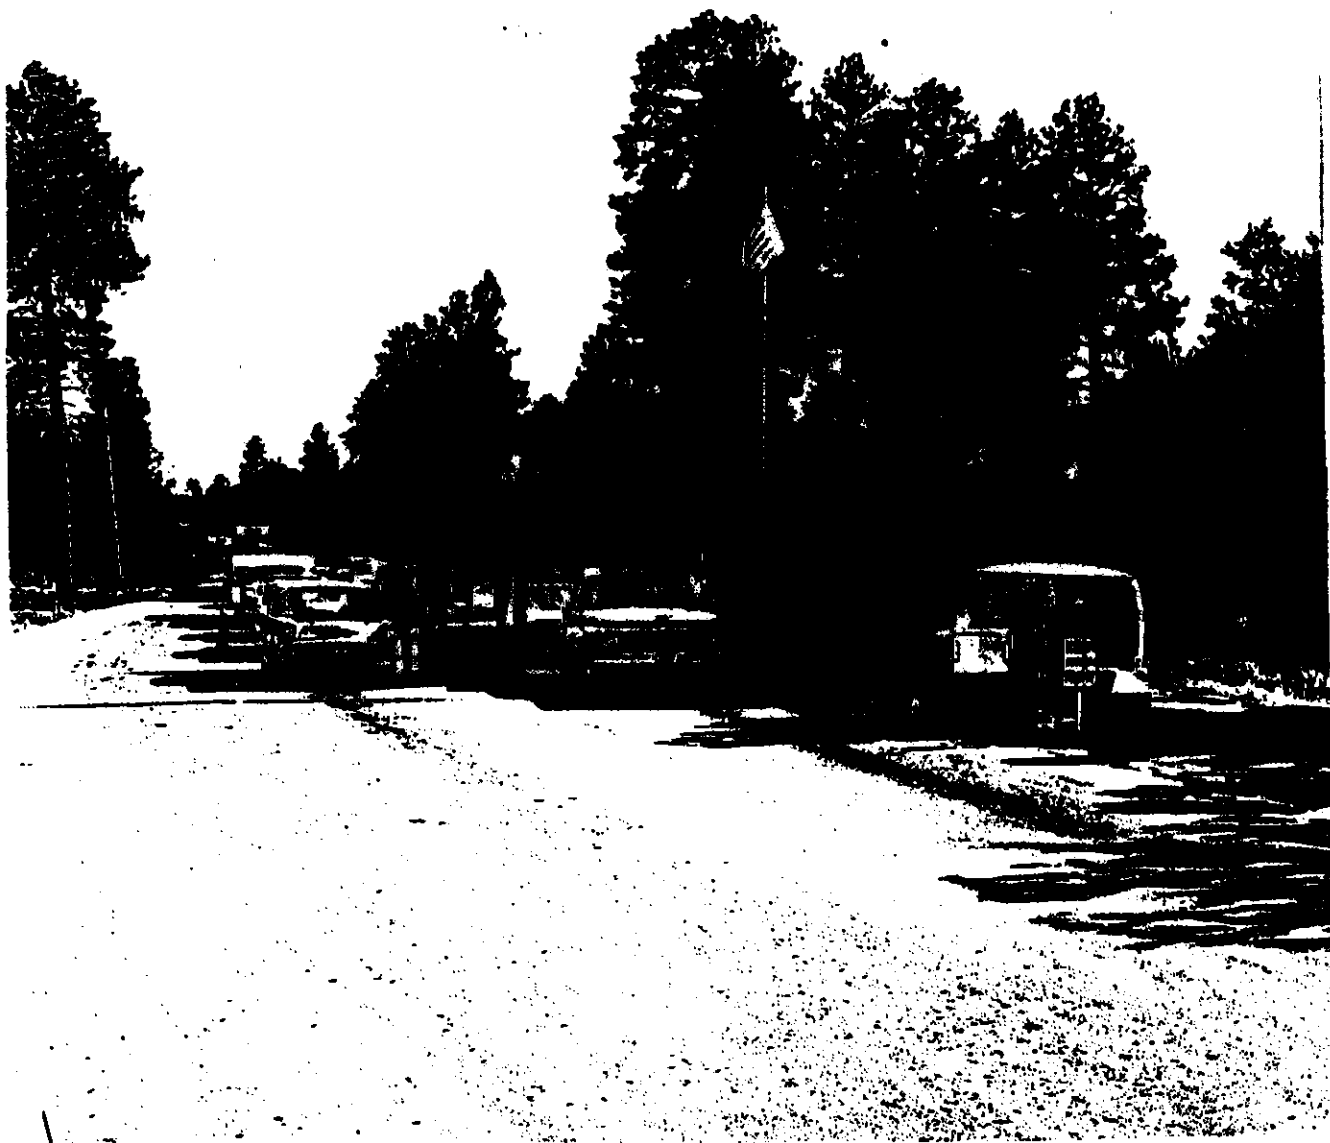
Figure 14. New South Entrance Station, 15 July 1963, facing south
(GRCA Image #4275, GCSC)

38. USDI, NPS, "Entrance Station, 1958"; GRCA, Image #4275, 15 July 1963, photo of two buildings at entrance station, GCSC.
